**DEPARTMENT OF TRANSPORTATION**

Contract #: 04-0120F4Cty: SF/ALA Rte: 80 PM: 13.2/13.9File #: 69.28**WELDING INSPECTION REPORT****Resident Engineer:**Siegenthaler, Peter**Address:** 333 Burma Road**City:** Oakland, CA 94607**Report No:** WIR-025226**Date Inspected:** 13-Jun-2011**Project Name:** SAS Superstructure**OSM Arrival Time:** 1500**Prime Contractor:** American Bridge/Fluor Enterprises, a JV**OSM Departure Time:** 300**Contractor:** Zhenhua Port Machinery Company, Ltd (ZPMC), Changxing Island **Location:** ShangHai, China**CWI Name:** Shi Yu**CWI Present:** Yes No**Inspected CWI report:** Yes No N/A**Rod Oven in Use:** Yes No N/A**Electrode to specification:** Yes No N/A**Weld Procedures Followed:** Yes No N/A**Qualified Welders:** Yes No N/A**Verified Joint Fit-up:** Yes No N/A**Approved Drawings:** Yes No N/A**Approved WPS:** Yes No N/A**Delayed / Cancelled:** Yes No N/A**Bridge No:** 34-0006**Component:** OBG**Summary of Items Observed:**

**Blasting Bay # 4**

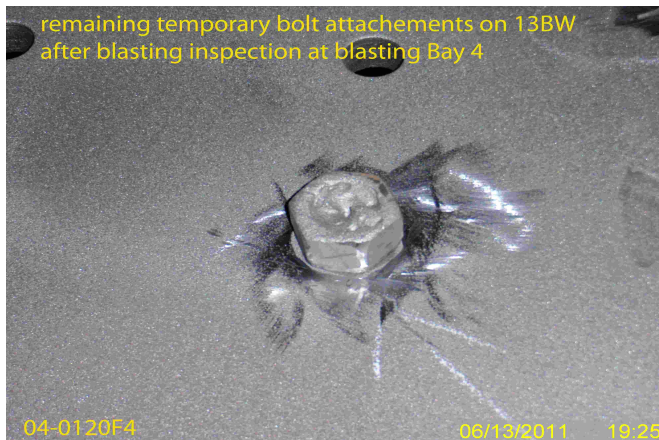
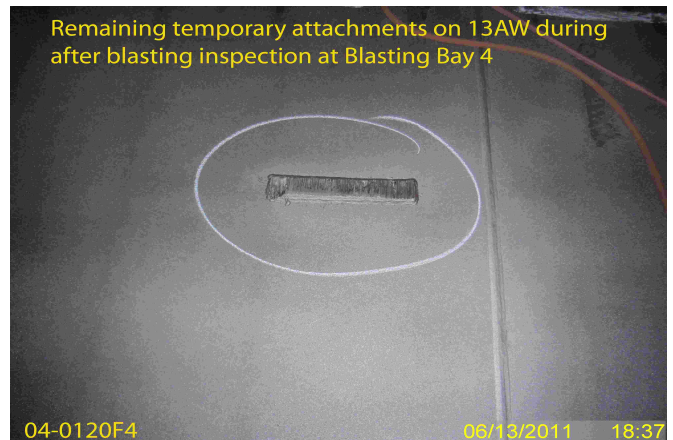
This QA inspector performed after blasting inspection on top deck plate of OBG 13 AW, BW, at blasting bay 4, QA inspector find out eight(8) locations of deep arc gouge marks to be weld repair areas and three(3) locations are need grind smooth of temporary support removed area.
